<h1 style="text-align: center;">Fiber Inspection</h1>

<b>Inspection Date</b> 3/17/2015 12:25:36 PM <b>Company Name</b> <b>Location</b> <b>Operator</b>					
<b>Fiber Information</b>					
<b>File Name</b> ED1_prt23_TX.pdf <b>Fiber Type</b> Simplex <b>Job ID</b> <b>Fiber ID</b> 22 <b>Comments</b> ED1 23 TX

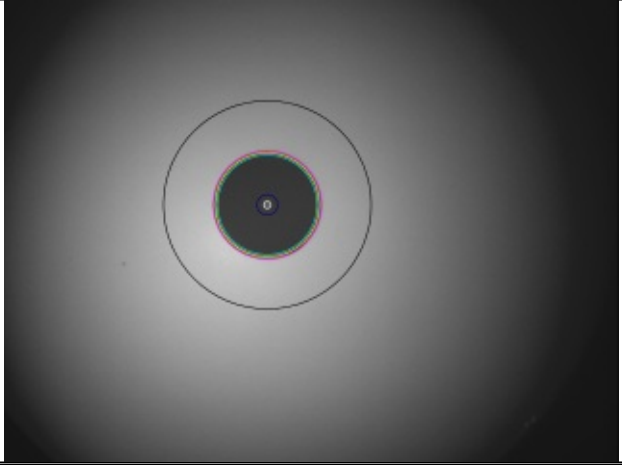
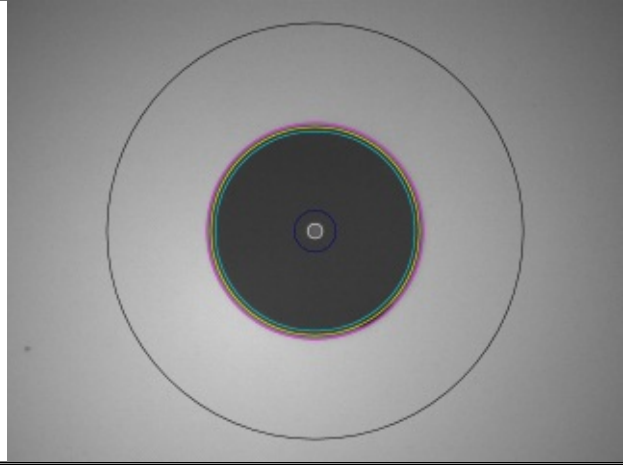
<b>Inspection Summary</b>					
<b>Profile Name</b>		SM UPC (IEC-61300-3-35)			
<b>Zone</b>		<b>Defects</b>		<b>Scratches</b>	
Zone A (0 - 25)		PASS		PASS	
Zone B (25 - 120)		PASS		PASS	
Zone C (120 - 130)		PASS		PASS	
Zone D (130 - 250)		PASS		PASS	
<b>Low Magnification</b>			<b>High Magnification</b>
